TS-PIC-91098  
December 1991

**EPA Site Analysis**  
**L.E. Carpenter & Company**  
**Wharton, New Jersey**

Site Analysis  
L.E. Carpenter & Co.  
Wharton, New Jersey

by  
Peter E. Bracken, Imagery Analyst  
The Bionetics Corporation  
Warrenton, Virginia 22186

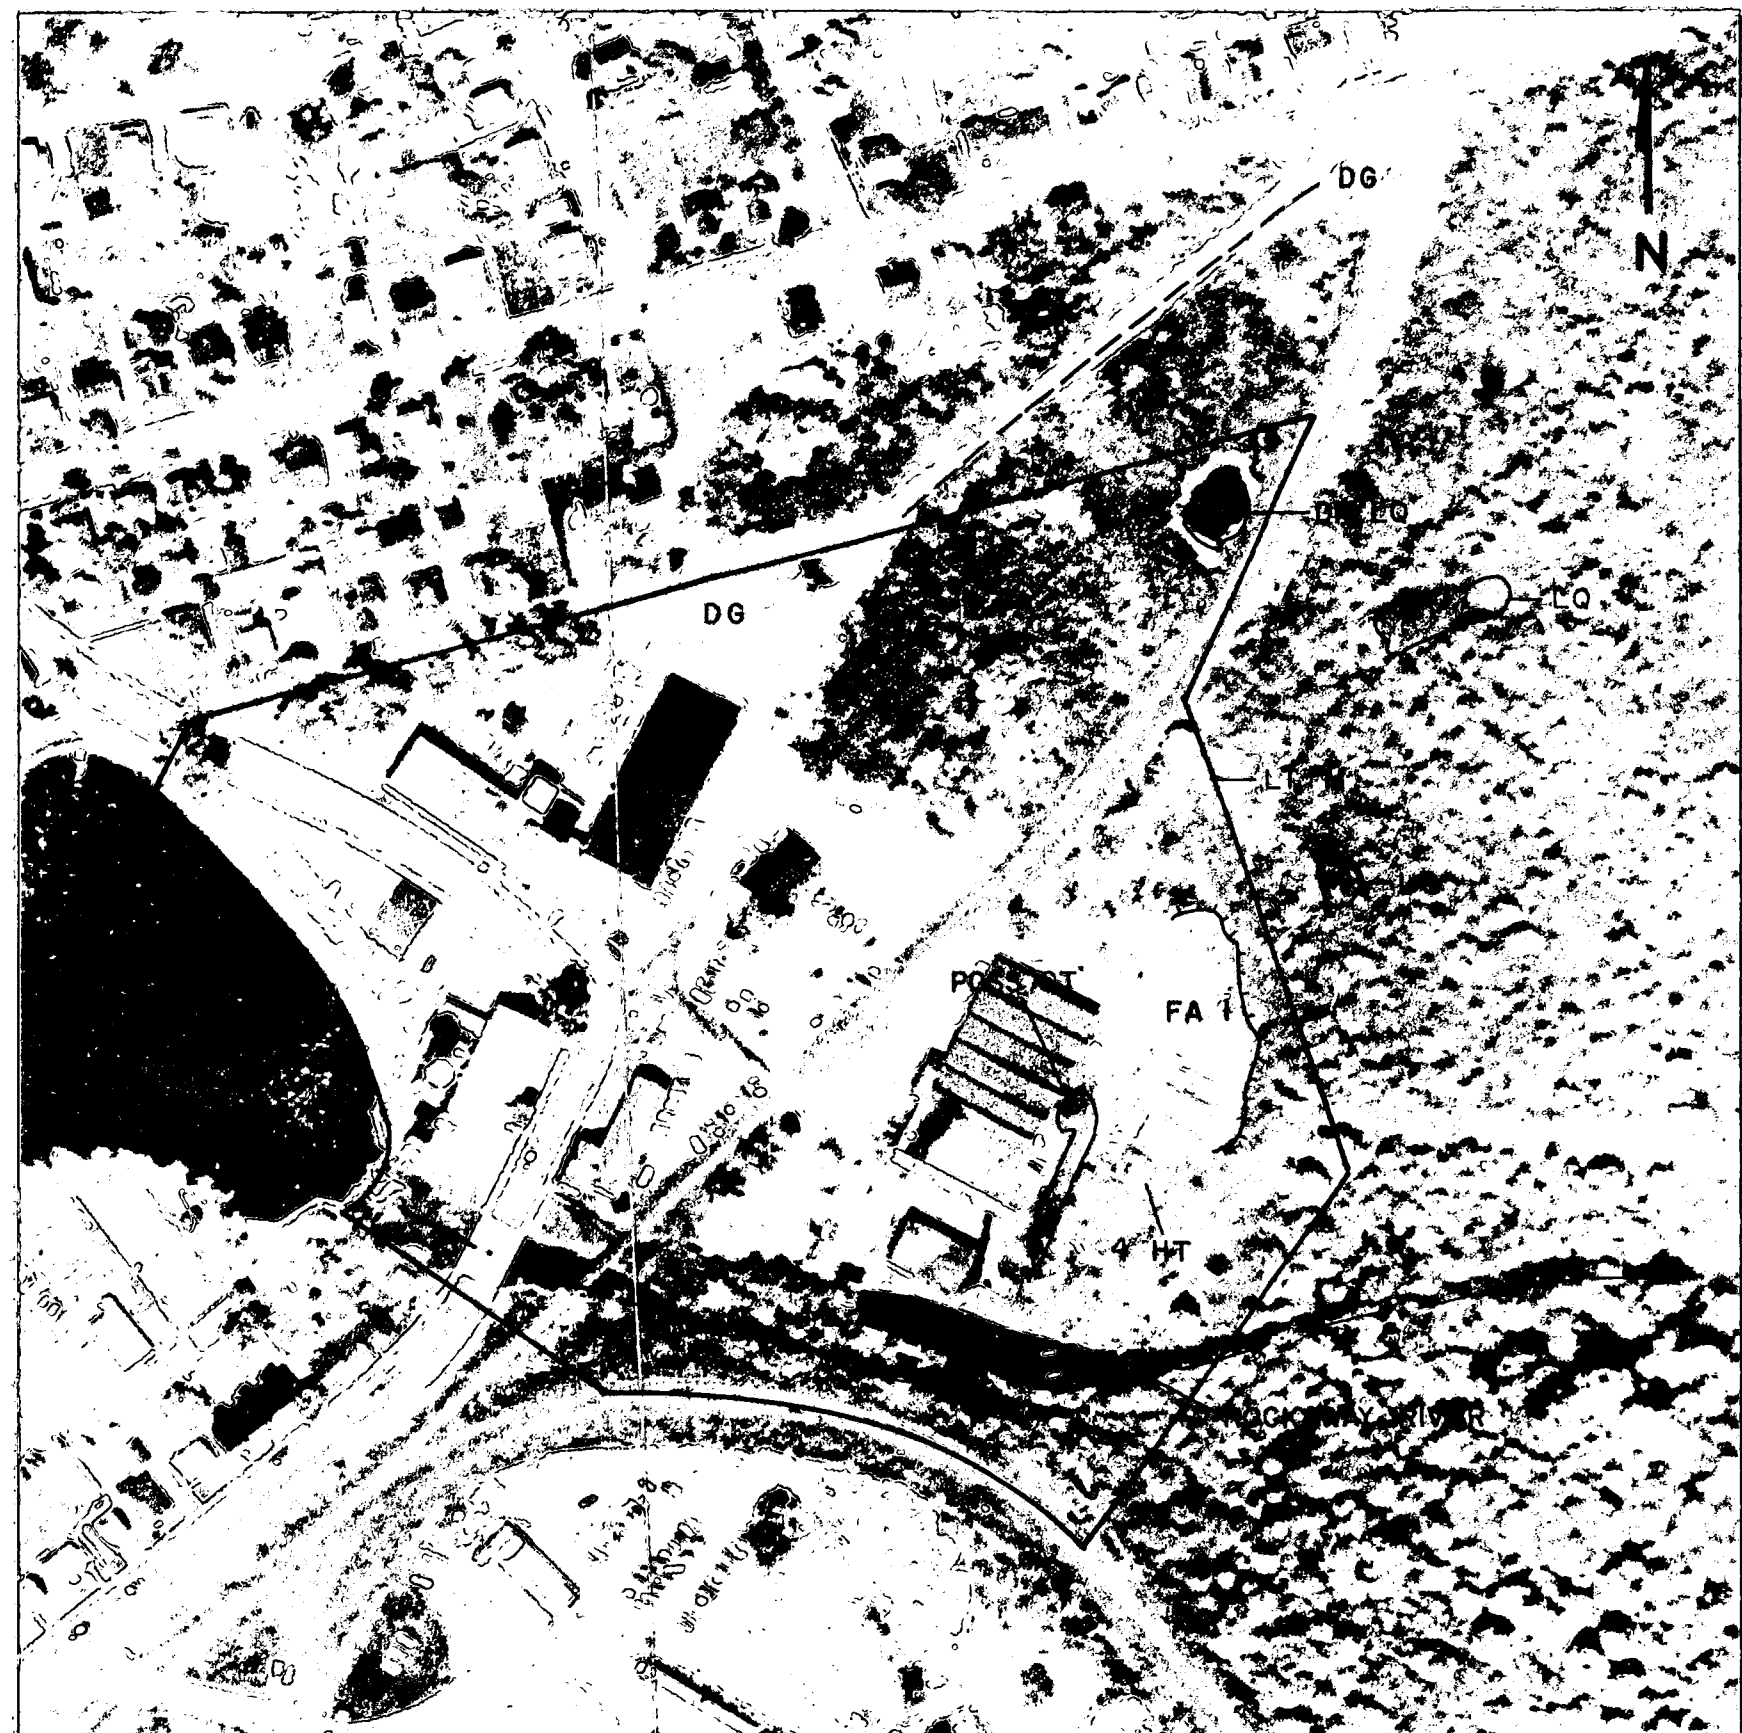
FIGURE 4  
L.E. CARPENTER & CO.

Liquid - Two new pools of liquid are seen east of the site. These two pools will continue to be annotated, but are not discussed further.

Disturbed Ground (DG) - Two areas of disturbed ground are seen. An access road connects the disturbed ground in the northern portion of the site to that located north of the study area. These features may be associated with burial, possibly a sewer or water line.

Light-Toned (LT) Material (M) - Located in the northeastern portion of the site, and may be related to waste disposal. This light-toned material will continue to be annotated, but is not discussed unless associated with a significant observation.

Fill Area 1 (FA1) - This area was filled sometime after 1951.

Possible Stain (ST) - Dark-toned possible stain appears to originate from the east side of a large building. This possible stain extends south from the building.

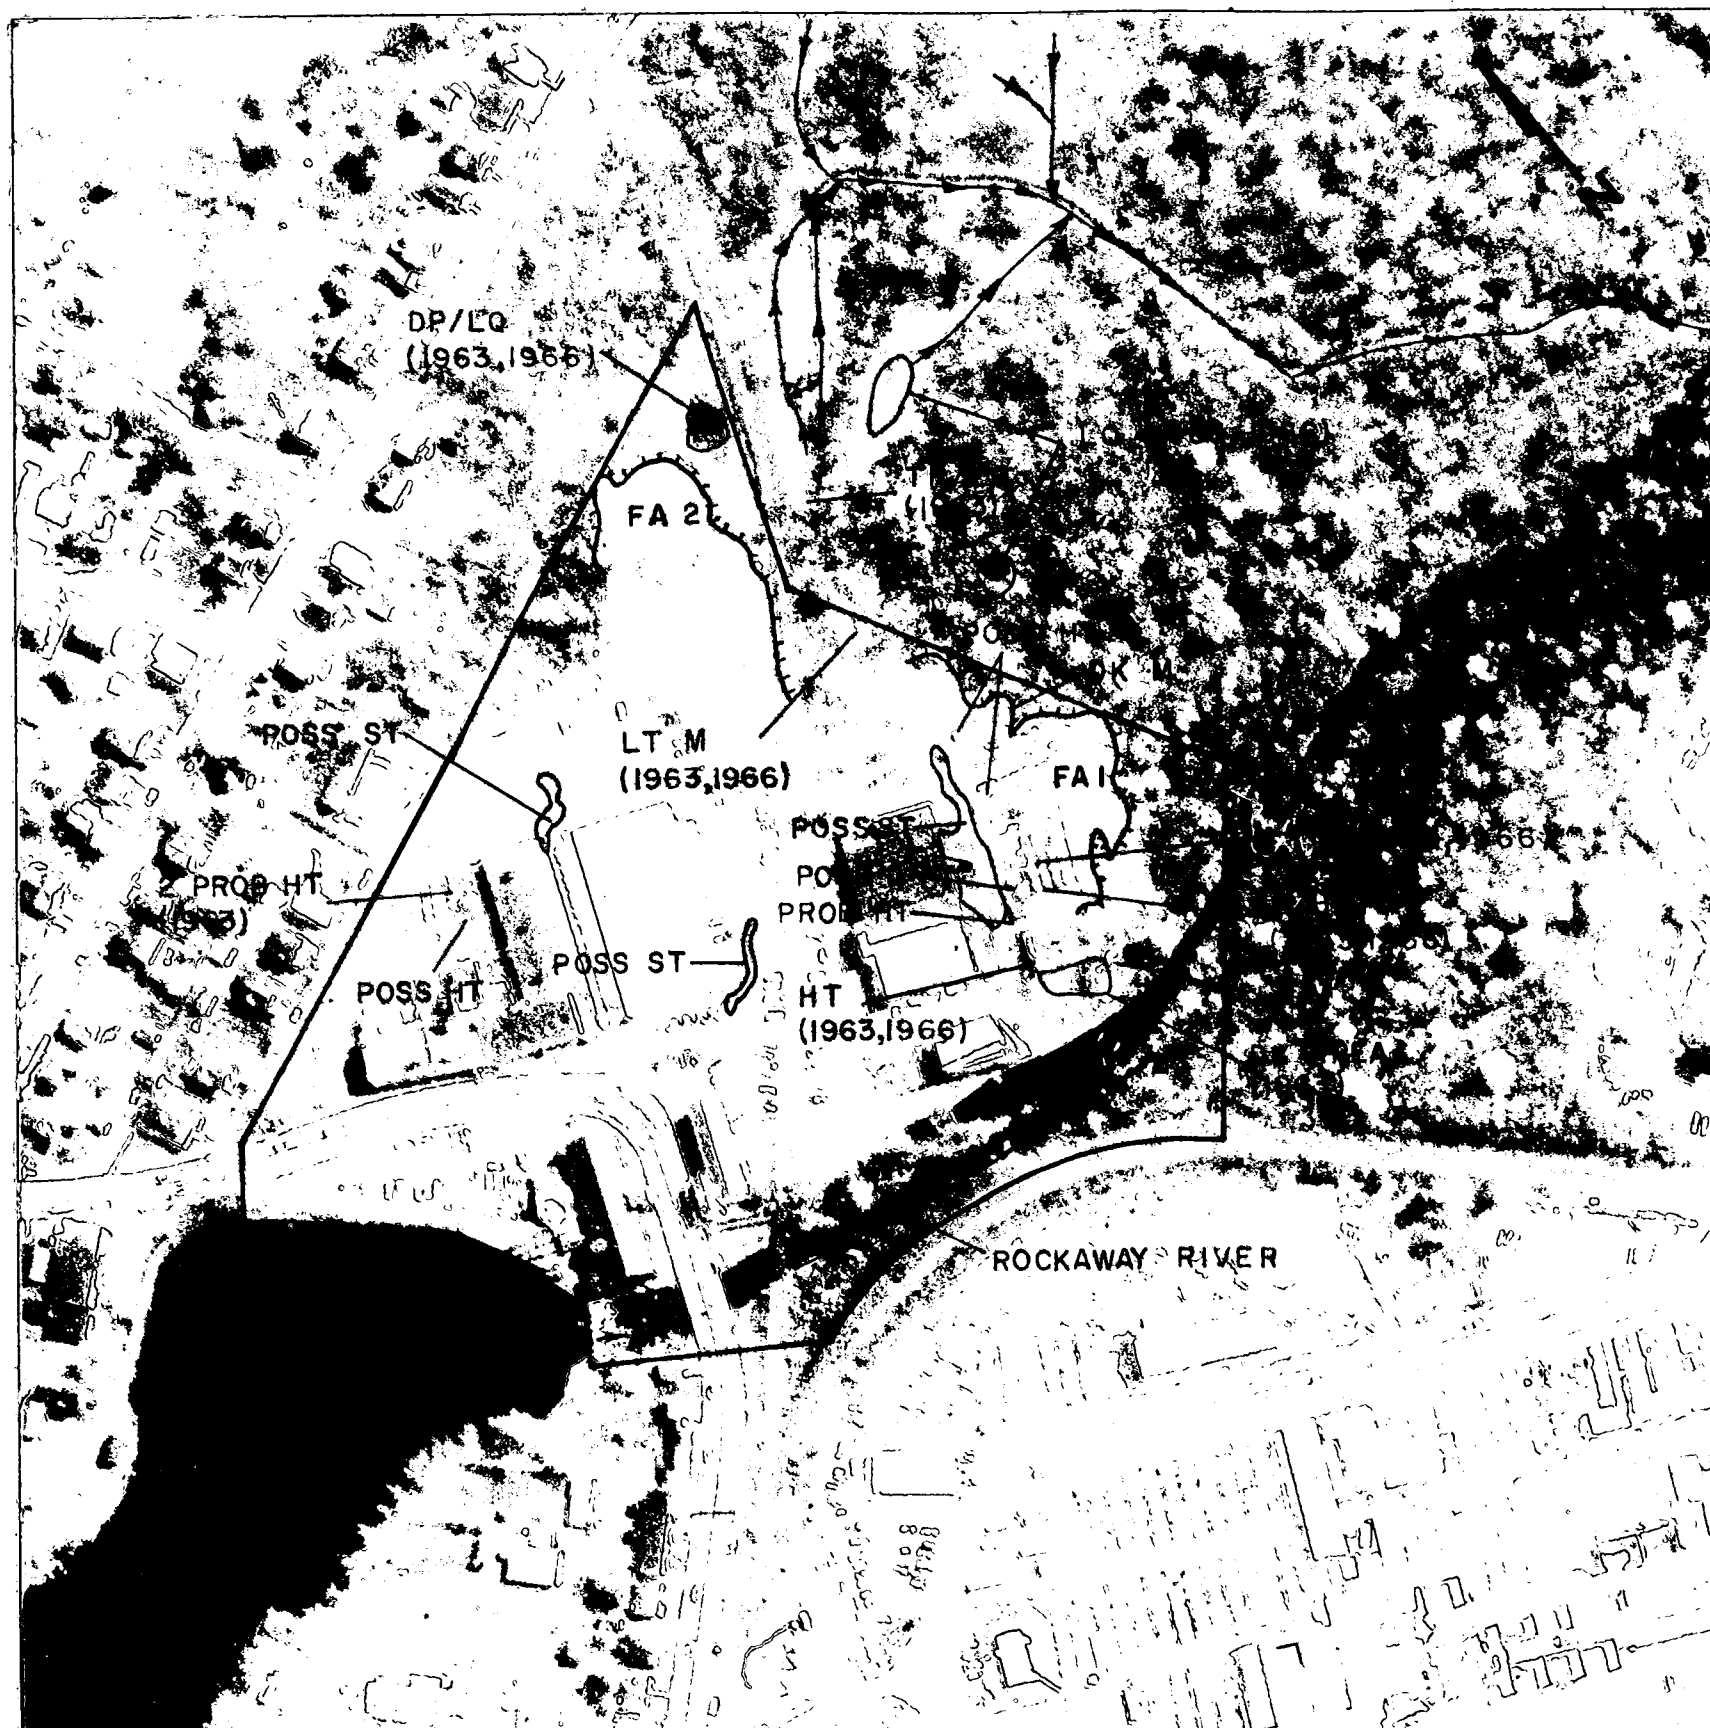
**FIGURE 5**  
**L.E. CARPENTER & CO.**

Drainage - A network of channelized drainage has been constructed northeast of the site. The channelized drainage, probably used to drain a wetlands area, discharges to the Rockaway River southeast of the site.

Disturbed Ground - The northern, offsite disturbed area and the dirt access road (not annotated) seen in 1957 have revegetated. The onsite disturbed area (not annotated) seen in 1957 is now covered by a parking lot.

Trench Filled with Liquid (TR/LQ 1963) - No longer seen; probably part of drainage channel network.

Dark-Toned (DK) Material - Seen along the base of FA1. May be related to disposal.

FA1 (1963, 1966) - Has been expanded steadily eastward since 1957.

FA2 - This previously wet area was filled sometime after 1963.

Possible Stains - These dark-toned possible stains are visible in the central and eastern portions of the site. The easternmost stain is present where a dark-toned possible stain was seen in 1957.

Possible Drums (D) - Approximately 10 possible drums are seen adjacent to several horizontal tanks in the eastern portion of the site.

Light-Toned Material - Located in the southeastern portion of the site; may be related to waste disposal.

Dark-Toned Area (1963) - A rectangular dark-toned area was noted in 1963 in the same general location as a possible impoundment seen in 1951.

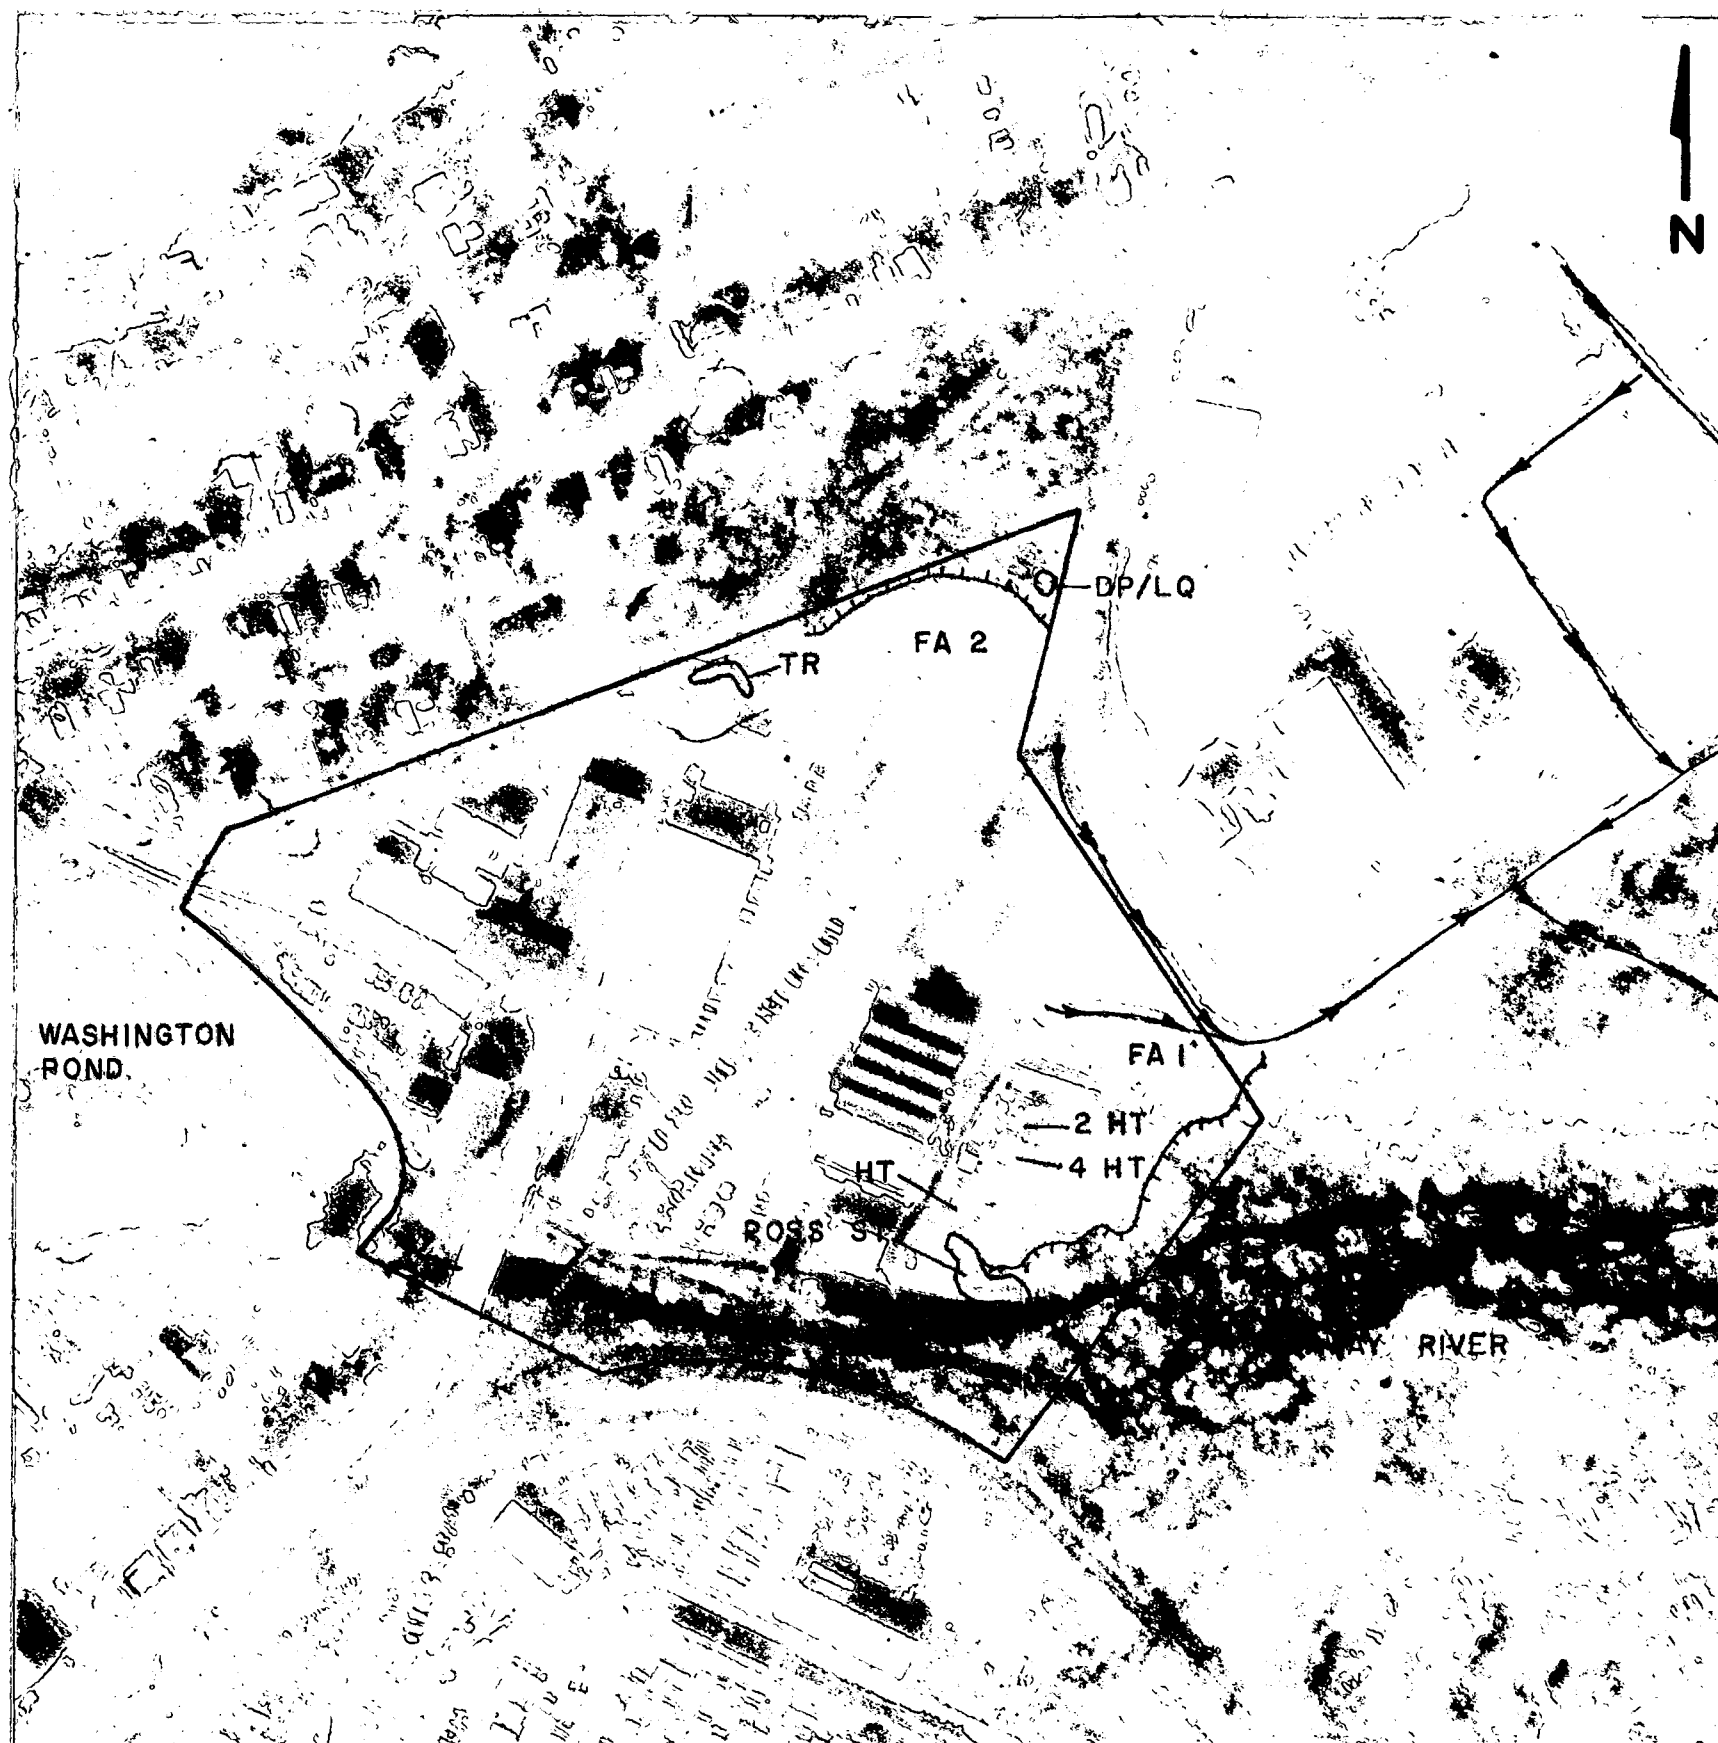
FIGURE 6

NOTE: Several of the features mentioned in 1966 are no longer seen due to the construction of the Air Products and Chemicals, Inc. facility just northeast of the site.

FA1 - Has been expanded north and east. It is bordered to the north by channelized drainage along the site boundary.

FA2 - Has been expanded farther north. The fill material seen along the fill face is coarse-textured and may be debris.

Trench - An L-shaped trench in the northern portion of the site may be related to drainage.

Possible Stain - A dark-toned possible stain seen in the southeast corner of the site may originate from the same building as two possible stains seen in 1957 and 1966.

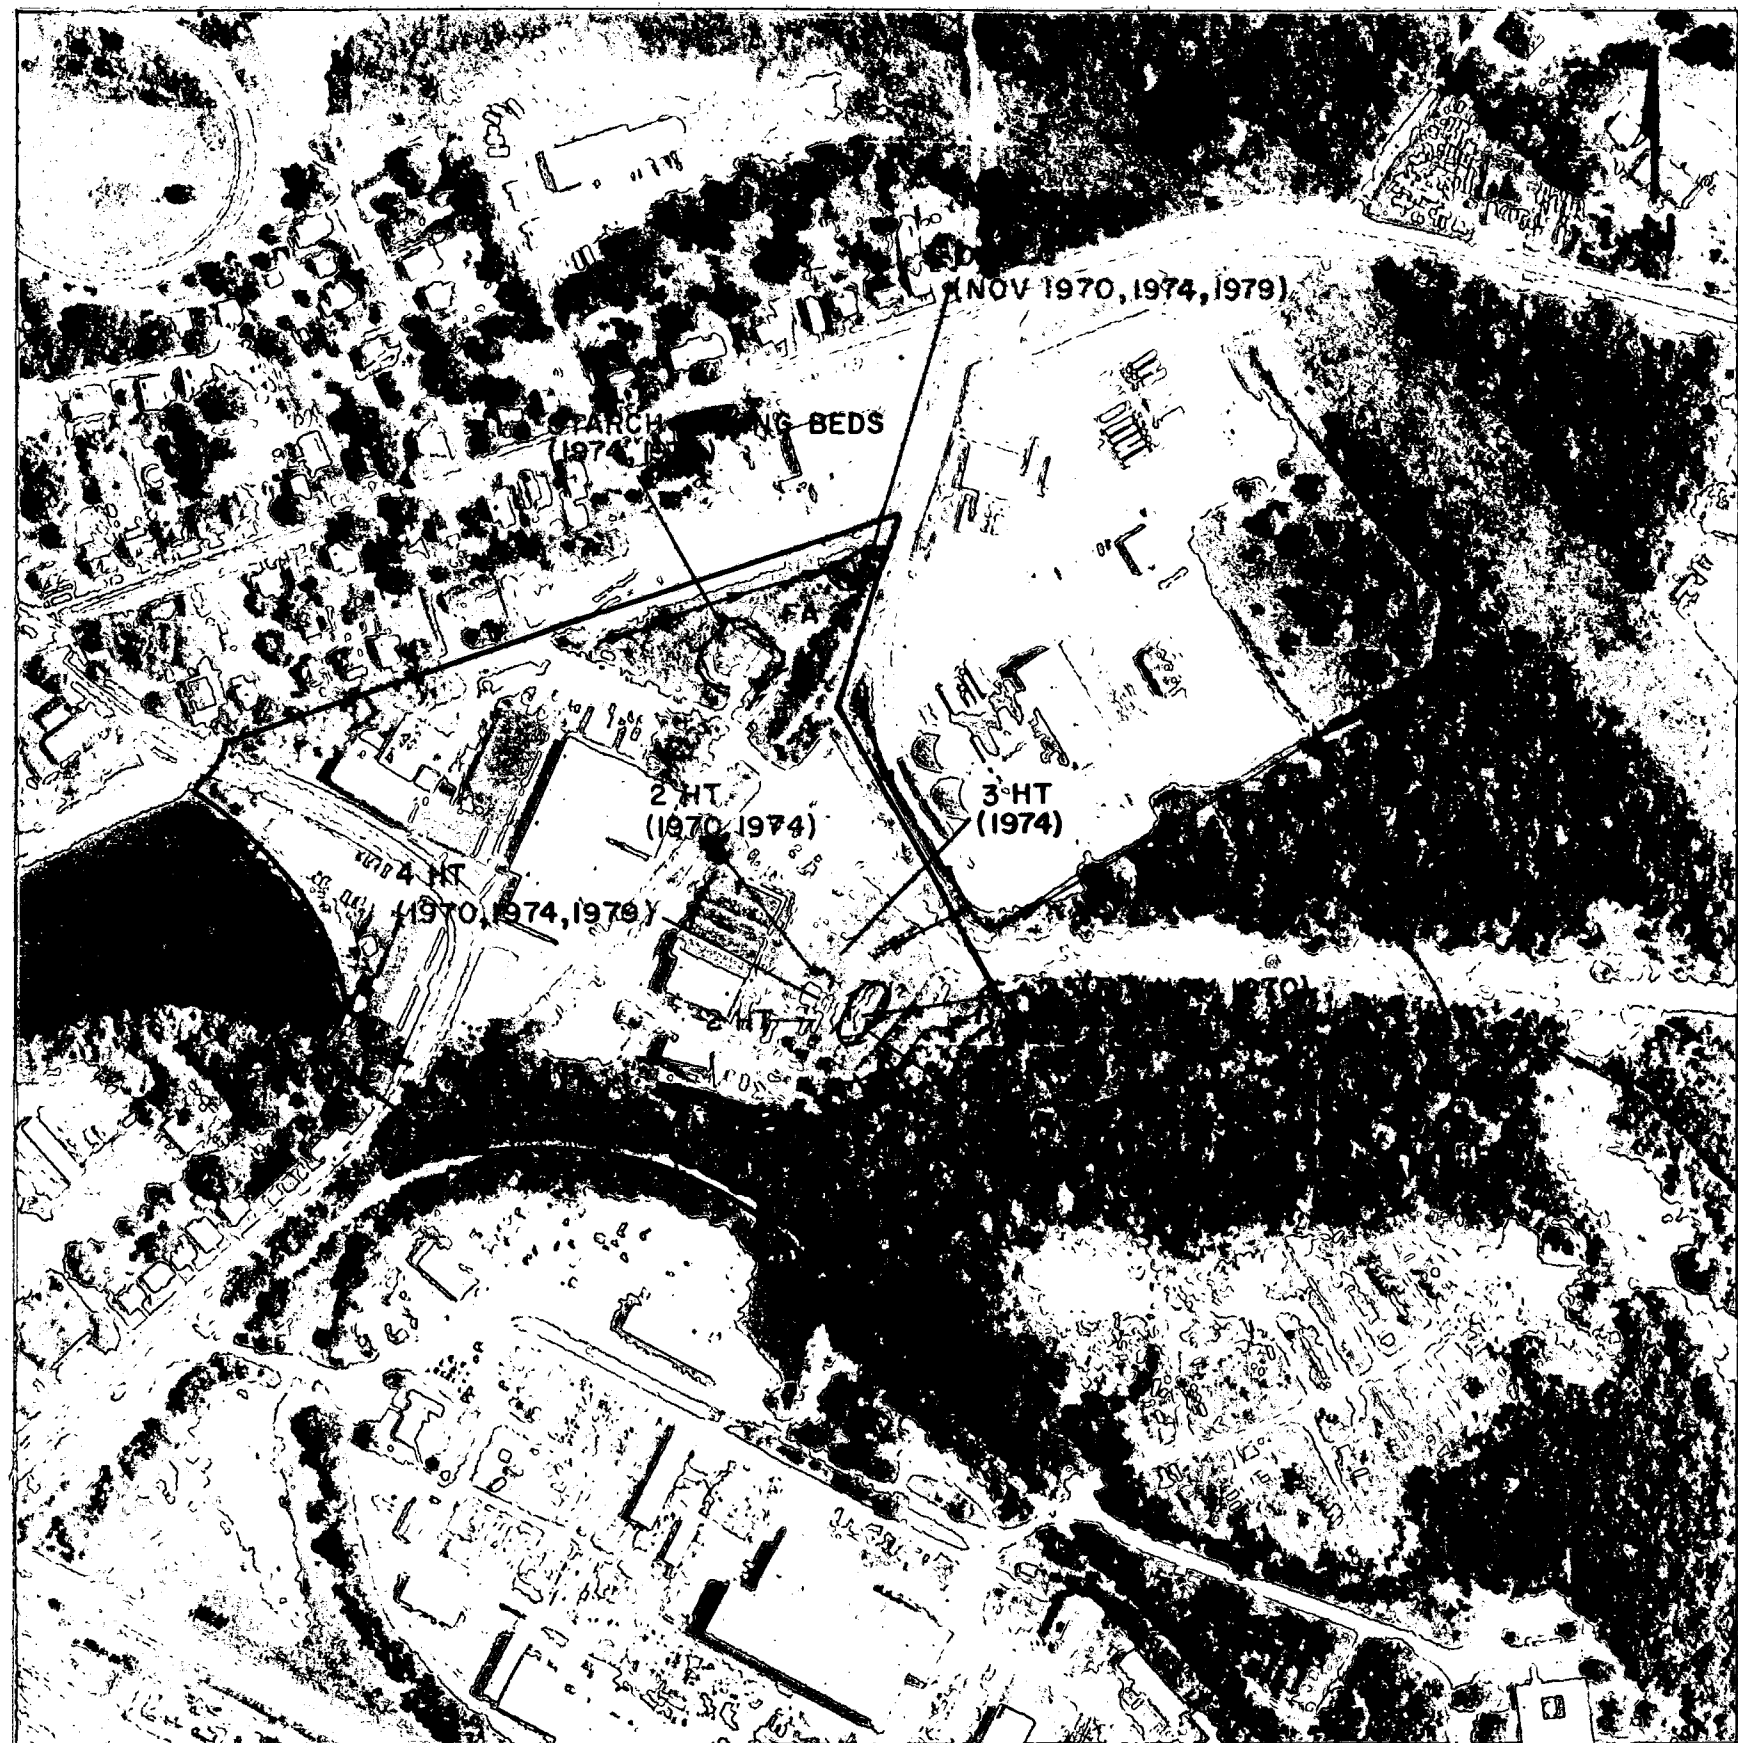
FIGURE 7  
L.E CARPENTER & CO.

Starch Drying Beds\* - The beds are bermed on four sides and built on top of FA2. They are used for the biodegradation of water-soluble starches. Three parallel rows of linear objects (not annotated) are visible inside the berm of the drying beds. One row of linear objects (not annotated) is seen outside the north berm.

FA1 - Has been expanded slightly east. NOTE: The light-toned, linear ground scar extending east from FA1 is probably related to sewer line construction.\*

FA2 - Has revegetated. Will continue to be annotated, but is no longer discussed.

Impoundment (IM 1974, 1979) - Rectangular, surrounded by a berm on four sides. Two long, parallel trenches were seen at this location in November 1970. These trenches are probably related to the construction of the impoundment. NOTE: An impoundment is reported to have existed at this location from 1963 to 1970.\* However, no impoundment was detected in this area until 1974.

Trench - Located just east of the impoundment.

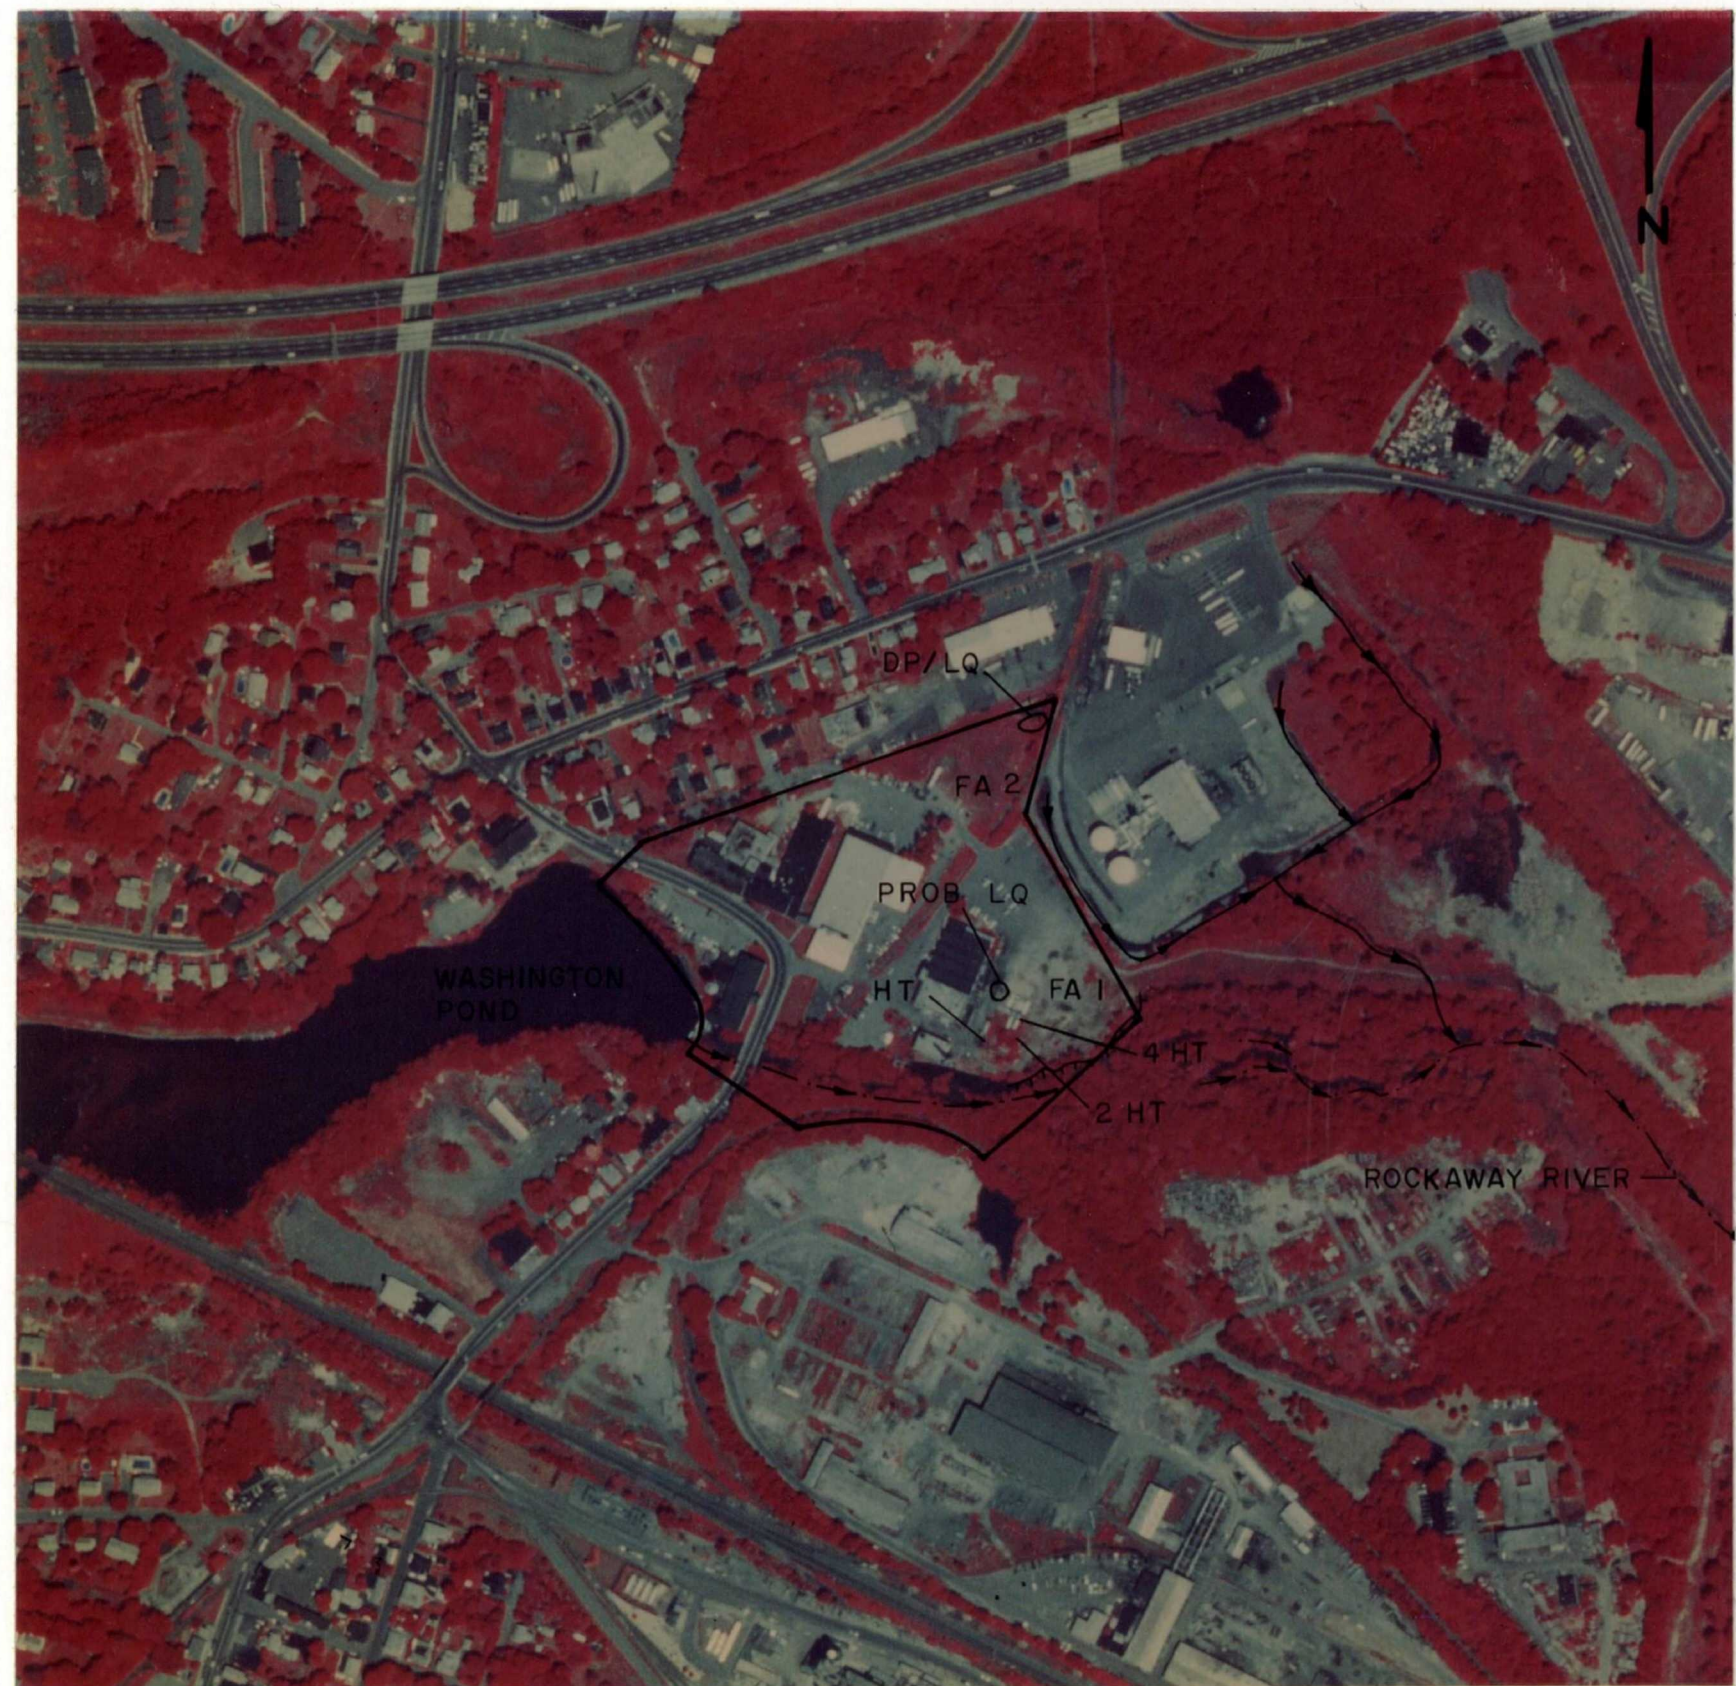
FIGURE 8  
L.E. CARPENTER & CO. JUNE 23, 1983 APPROX. SCALE 1:4,600

Starch Drying Beds - No longer present.

FA1 - Has been expanded slightly southeast.

Probable Liquid - Located along the east side of a building in the eastern portion of the site. This is the same general location where possible stains were seen in 1957 and 1966.
